INDOOR AIR QUALITY ASSESSMENT

**Massachusetts Commission for the Blind
800 Purchase Street
New Bedford, Massachusetts**

Prepared by:
Massachusetts Department of Public Health
Bureau of Environmental Health
Indoor Air Quality Program
October 2007

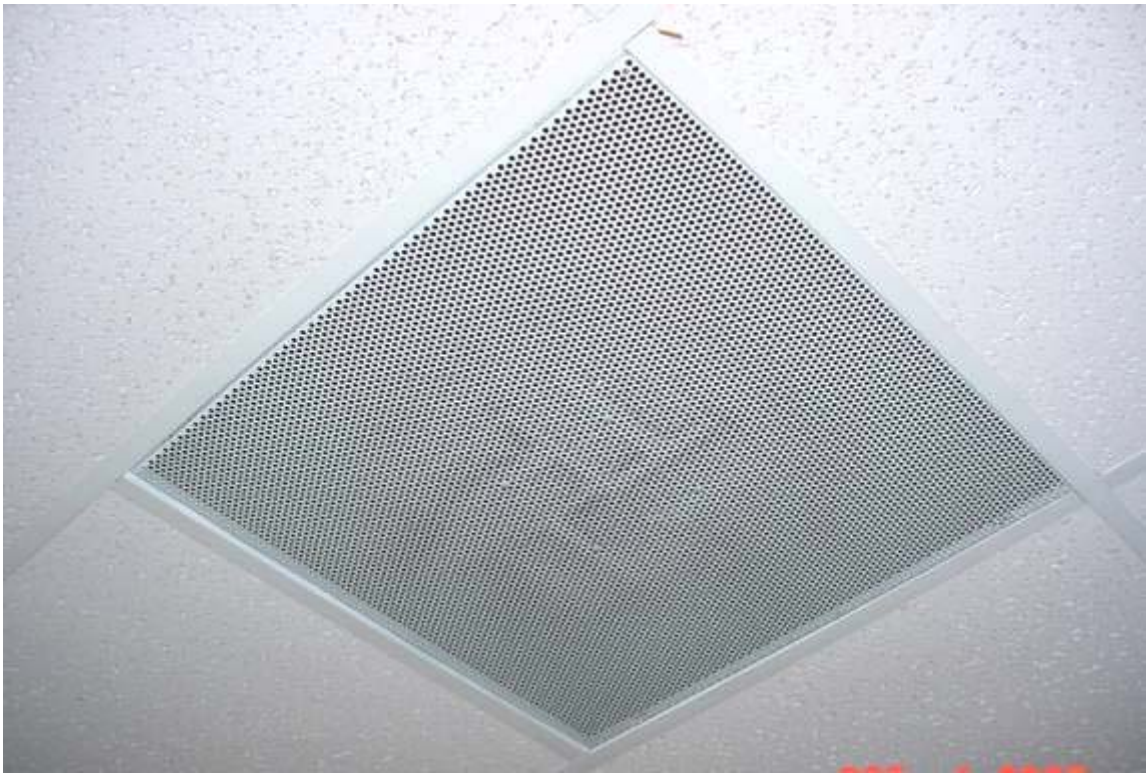
Picture 1

Mechanical ventilation is provided by rooftop air-handling units (AHUs). Fresh air is drawn into the AHUs and delivered to occupied areas via ceiling-mounted air diffusers (Pictures 1 and 2). Return air is drawn into a ceiling return plenum via ceiling-mounted grates (Picture 3) and ducted back to the AHUs. Airflow is facilitated and conditioned by a number of heat pumps located above ceiling tiles (Picture 4).

Ceiling-Mounted Supply Diffuser

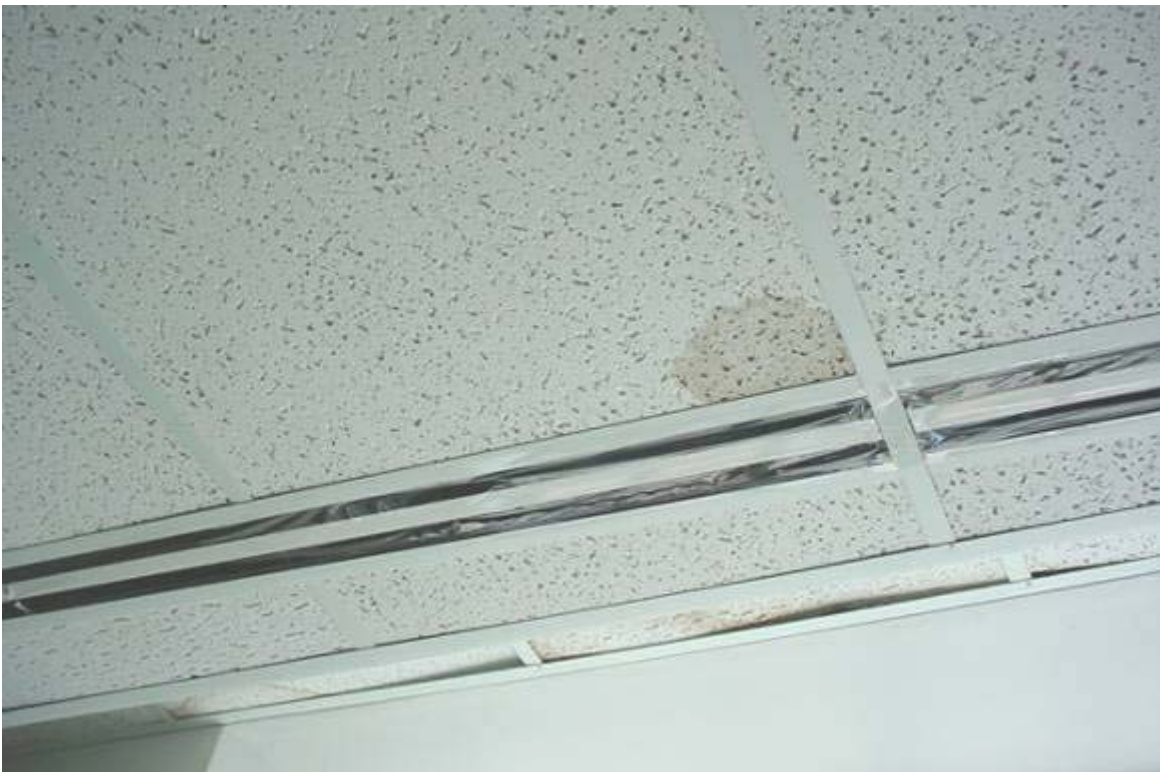
Picture 2

Slotted Supply Diffuser along Perimeter of MCB, Note Vents are Sealed with Clear Plastic Tape

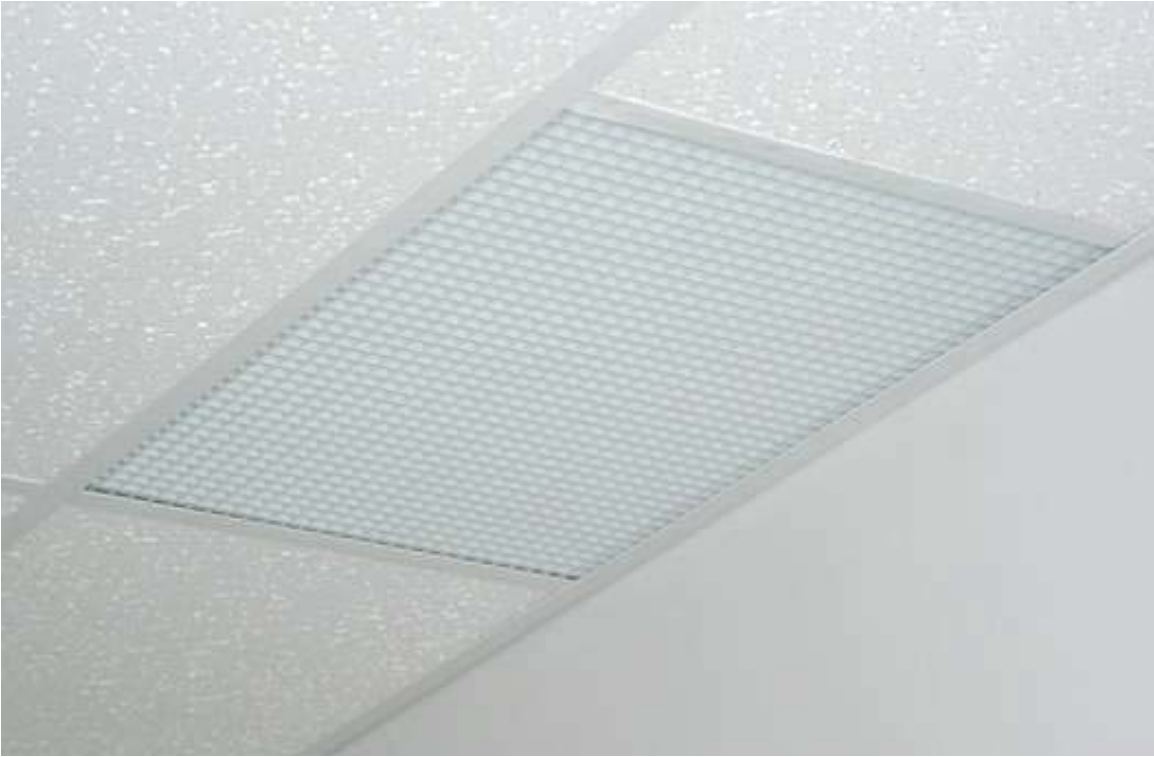
Picture 3

Ceiling-Mounted Exhaust Grate

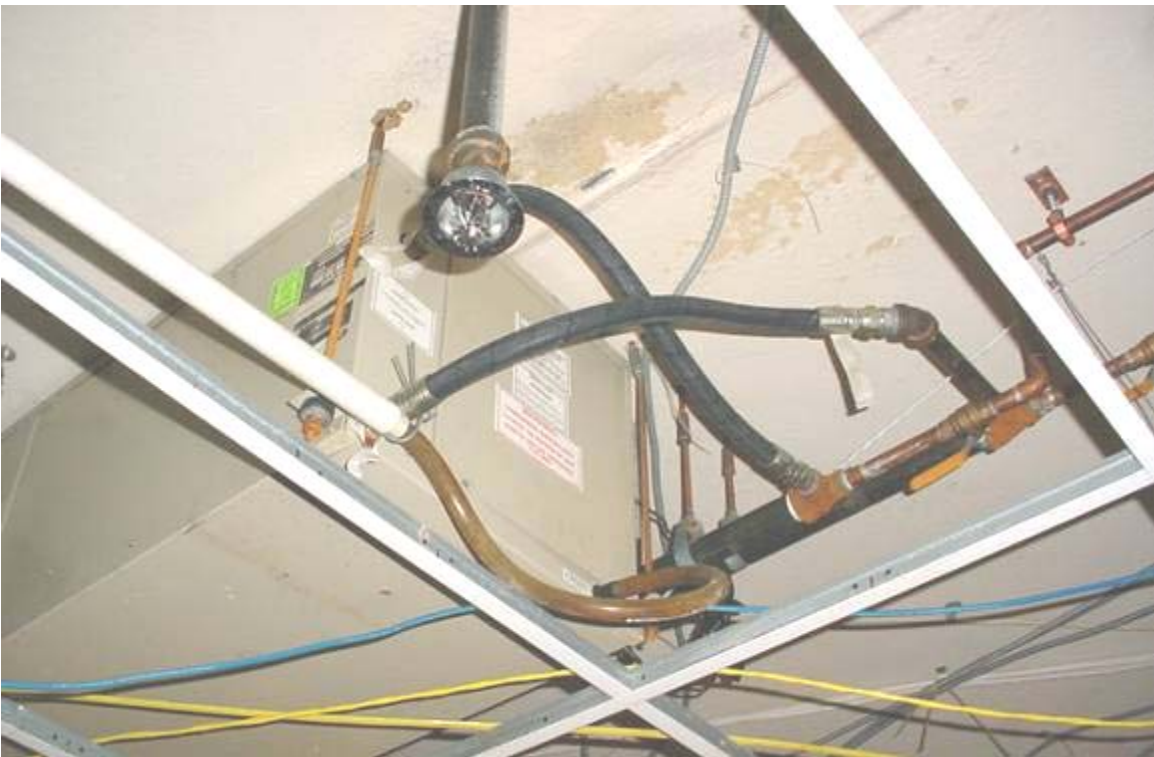
Picture 4

flooding had occurred due to a ruptured hose from a heat pump located above the ceiling tile system in the main area of the MCB. As a result, porous building materials [e.g., ceiling tiles, gypsum wallboard (GW), flooring and carpeting] were water damaged. As previously mentioned, remediation efforts were underway at the time of the assessment. Details regarding remediation are discussed in the *Microbial/Moisture Concerns* section of this assessment.

Heat Pump Located in Central MCB above Ceiling Tile System, Note Hose, Which was the Origen of the Flooding Incident

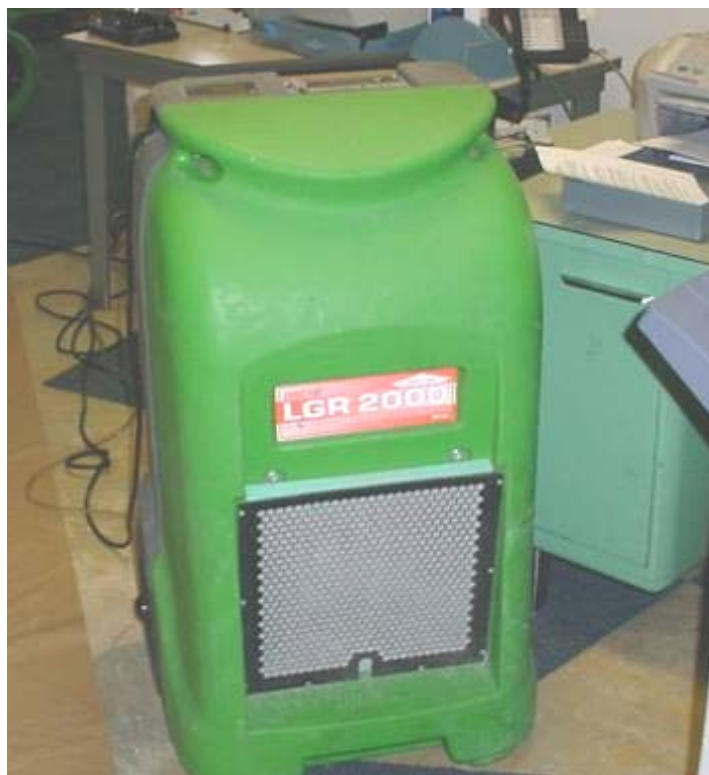
Picture 5

that during the assessment several industrial dehumidifiers were in use for drying operations (Picture 5). The MDPH recommends a comfort range of 40 to 60 percent for indoor air relative humidity. While temperature is mainly a comfort issue, relative humidity in excess of 70 percent for extended periods of time can provide an environment for mold and fungal growth (ASHRAE, 1989). Relative humidity levels in the building would be expected to drop during the winter months due to heating. The sensation of dryness and irritation is common in a low relative humidity environment. Low relative humidity is a very common problem during the heating season in the northeast part of the United States.

One of Several Industrial-Sized Dehumidifiers in use at the MCB

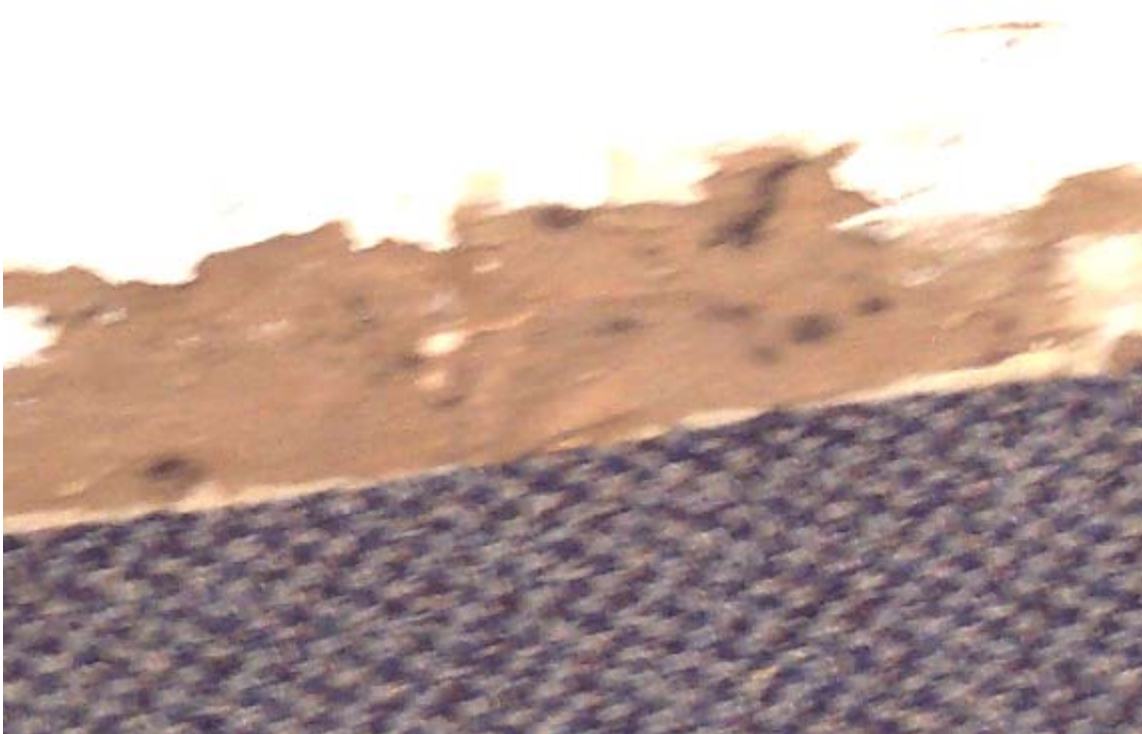
Picture 6

dried within this time frame, mold growth may occur. Once mold has colonized porous materials, they are difficult to clean and should be removed. Visible mold growth was observed behind vinyl base coving in UMass room 109 (Picture 6).

Visible Mold Growth (as Indicated by Dark Spots) behind Vinyl Base Coving in UMass room 109

1. Relocate staff from the central MCB in order to prevent exposure to remediation pollutants and facilitate drying.
2. Continue to remove and replace all water damaged/mold colonized porous building materials (i.e., GW in room UMass 109, ceiling tiles and carpet squares in the MCB). This measure will remove actively growing mold colonies that may be present. This work should be conducted at a time when occupants are not present in the area. Once work is completed, ensure that the area is thoroughly cleaned and disinfected with an appropriate antimicrobial. Dust and particulates resulting from renovation efforts in carpeted areas should be vacuumed with a HEPA filtered vacuum cleaner.

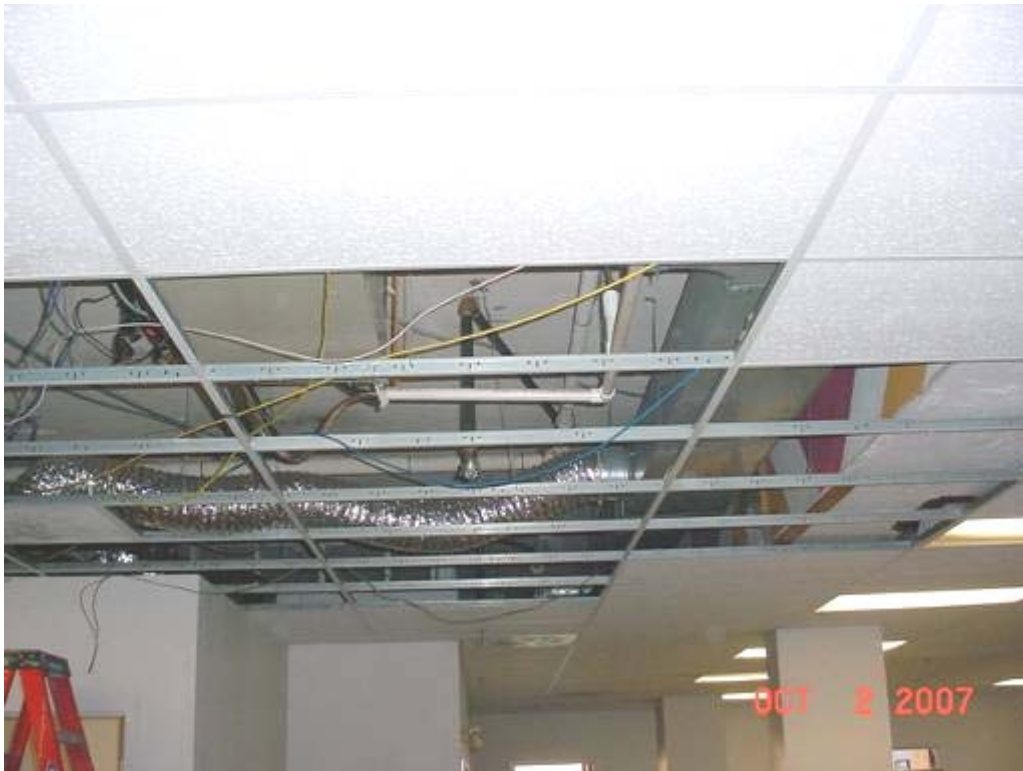
Picture 7

At the time of the assessment, water damaged ceiling tiles, GW and carpet squares in a number of areas had been removed to aid in drying the ceiling plenum, wall cavities and floor, respectively (Pictures 7 to 9). Drying was being achieved through the use of industrial floor fans and dehumidifiers, but was limited by the presence of office furnishings, other office materials and staff in the main area of the MCB (Picture 10).

Ceiling Tiles Removed to Dry Ceiling Plenum

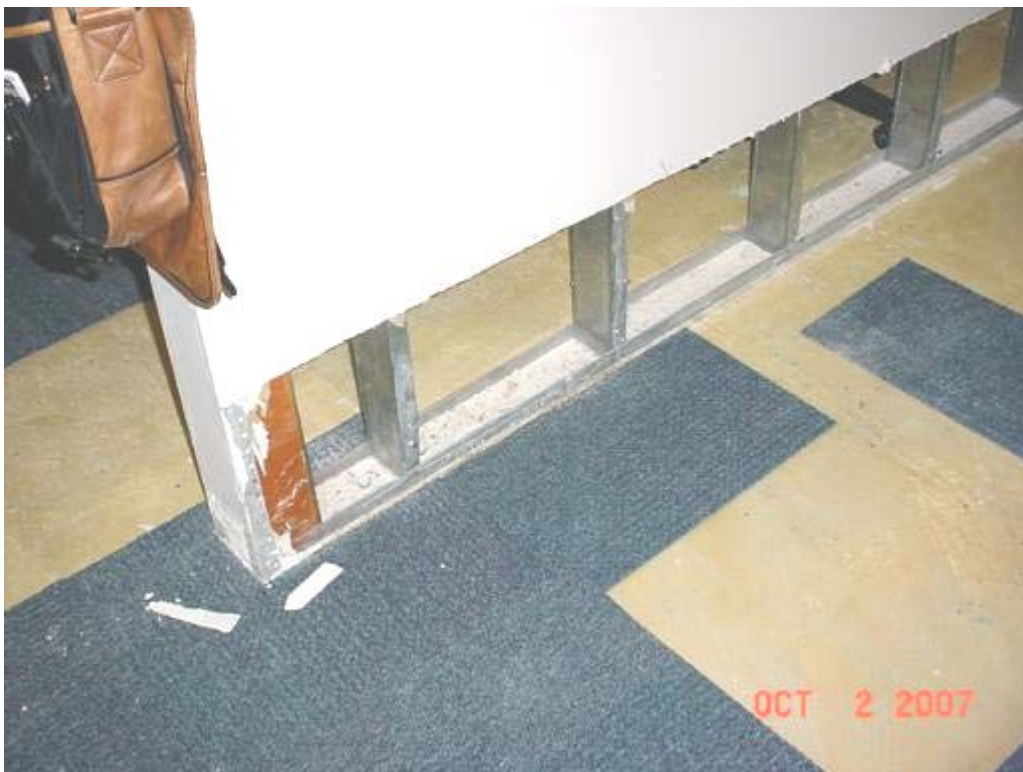
Picture 8

Portions of GW and Carpet Squares Removed

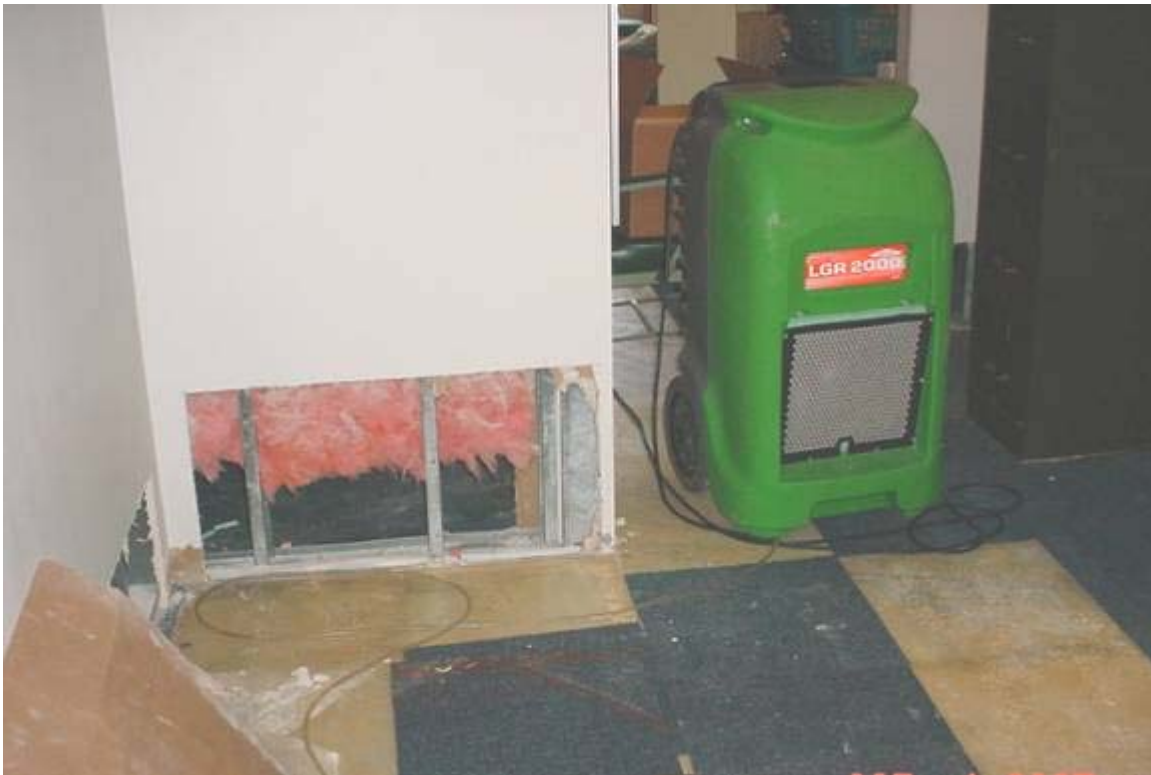
Picture 9

Portions of GW and Carpet Squared Removes, Note Exposed Fiberglass Insulation

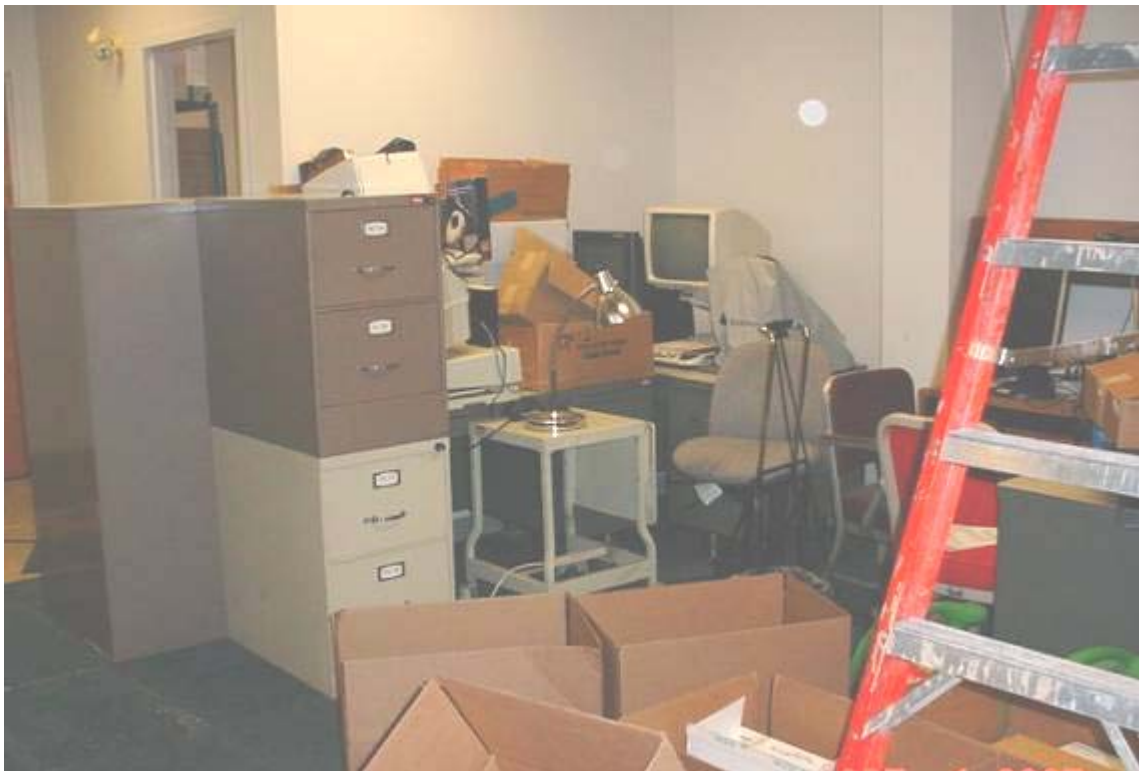
Picture 10

Office Furnishings and Other Items in Main Area of the MCB

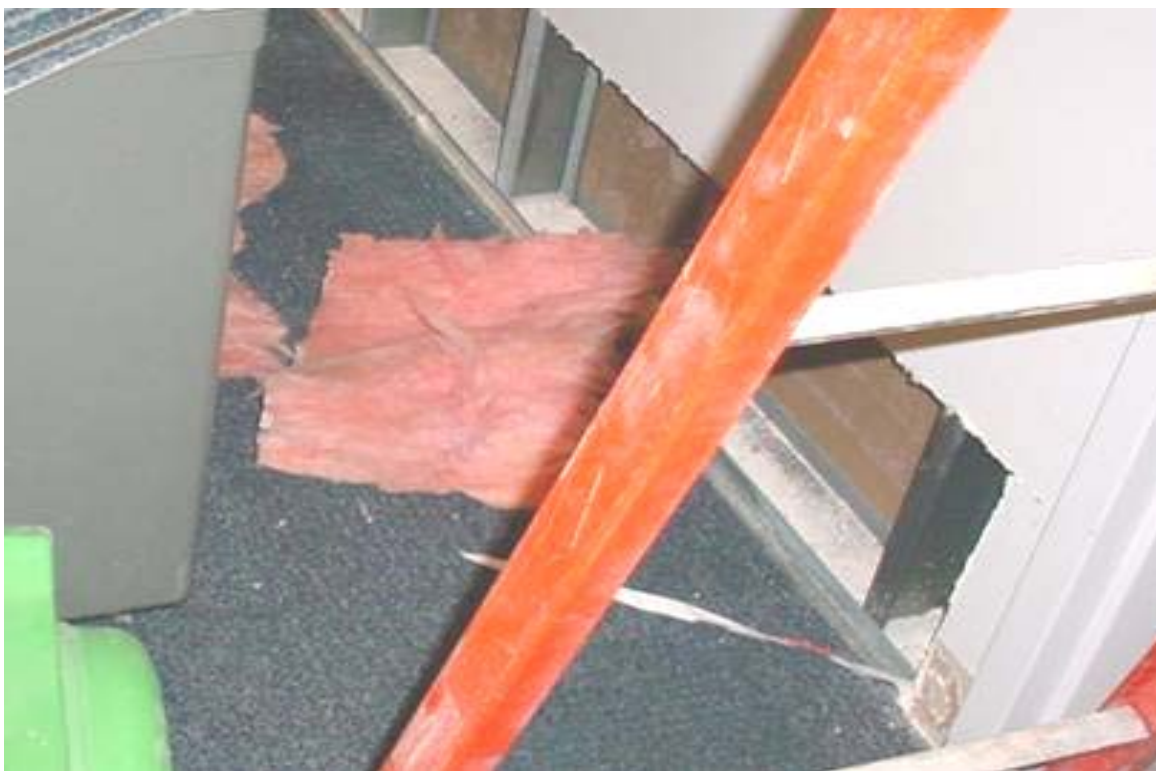
Picture 11

The main area of the MCB where the water damage occurred should be considered a remediation site. At the time of the assessment, Mr. Holmes recommended that opportunities for exposure be reduced/eliminated by temporarily relocating staff located in the main area of the MCB off-site or to perimeter offices within the building that were not affected by the water damage. Mr. Holmes emphasized the importance of preventive measures (e.g., isolation, pressurization, dust control) when conducting remediation to reduce/eliminate any possible migration of materials (e.g., mold spores, construction dust, fiberglass; Pictures 11 and 12) into non-remediation areas.

Fiberglass Insulation and GW Dust and Debris

6. Implement prudent housekeeping and work site practices to minimize exposure to renovation pollutants. To control for dusts, a HEPA equipped vacuum cleaner in conjunction with wet wiping/mopping of all surfaces is recommended.

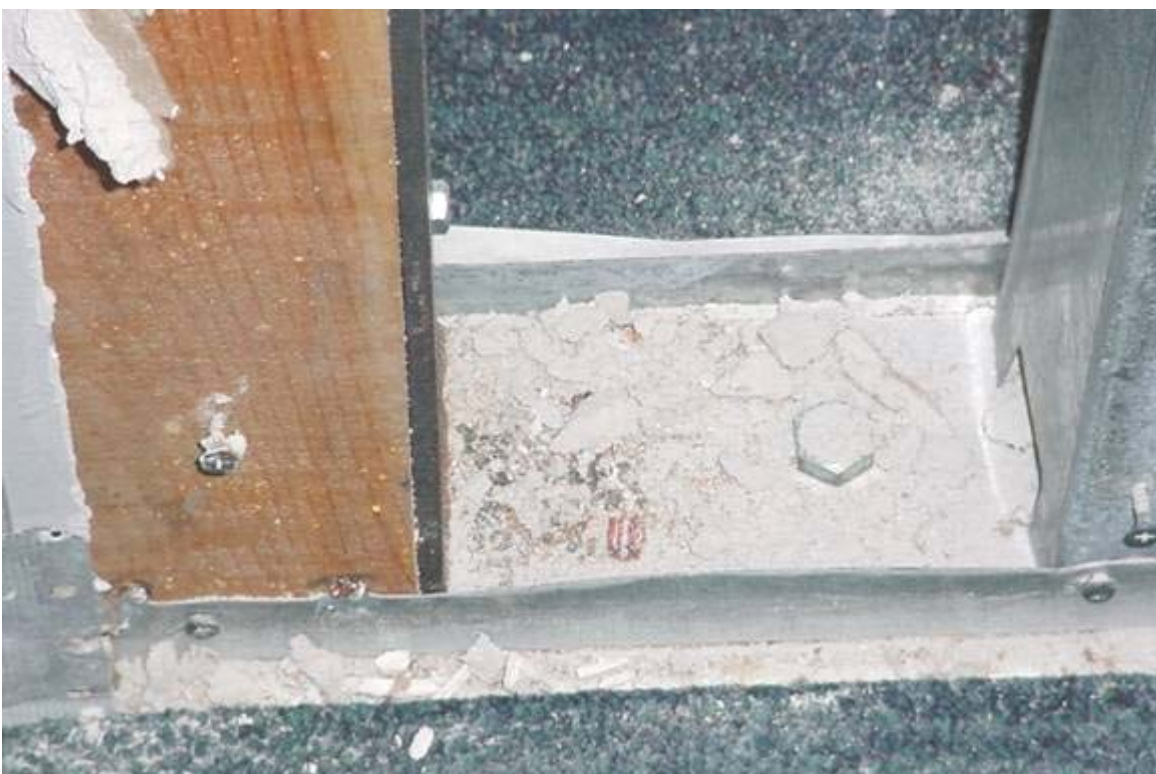
Picture 12

GW Dust and Debris

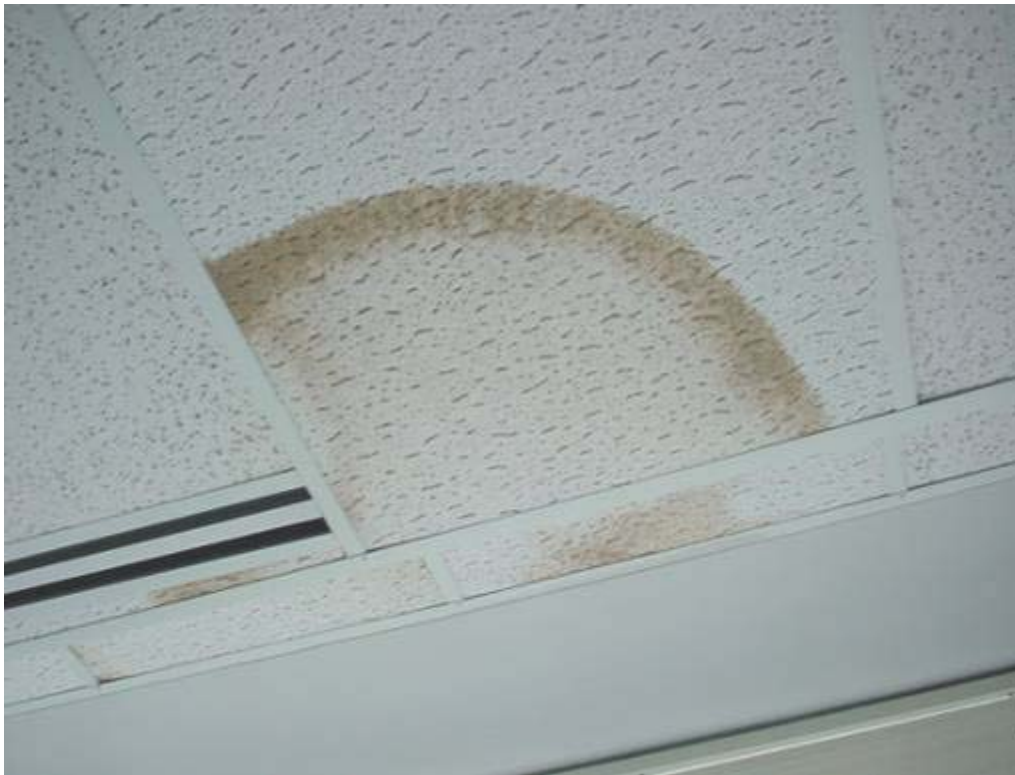
Picture 13

A few other potential mold sources were identified at the MCB. Several areas had water damaged ceiling tiles, which can indicate leaks from the roof or plumbing system (Picture 13). Water damaged ceiling tiles can provide a source of mold and should be replaced after a water leak is discovered and repaired. Breaches were observed between the counter and sink backsplash in the MCB break room (Picture 14). If not watertight, water can penetrate through these seams. Water penetration and chronic exposure of porous and wood-based materials can

Water Damaged Ceiling Tiles in Director's Office

10. Ensure leaks are repaired and replace water-damaged ceiling tiles. Examine the area above and around these areas for mold growth. Disinfect areas of water leaks with an appropriate antimicrobial.
11. Seal areas around sink in MCB break room to prevent water-damage to the interior of cabinets and adjacent wallboard.
12. Ensure MCB staff work in conjunction with building management and their HVAC vendor to examine the configuration of floor space and the placement of supply diffusers as a means to improve thermal comfort/temperature control it is recommended.

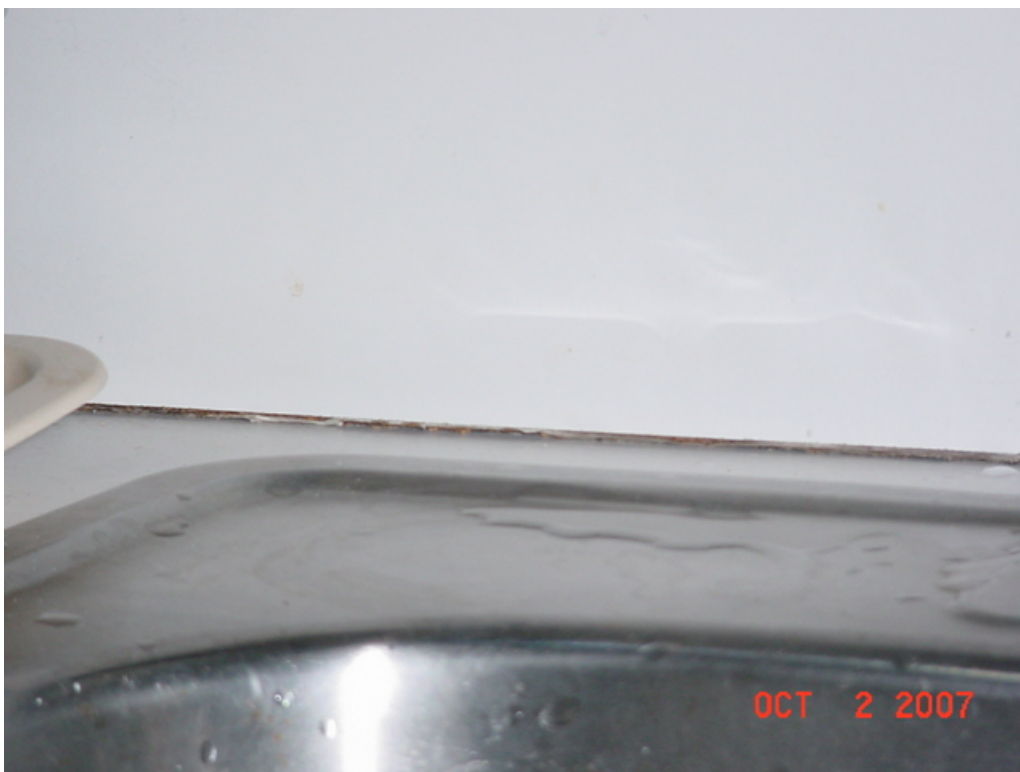
Picture 14

cause these materials to swell and show signs of water damage, which can subsequently lead to mold growth.

Breach between Sink Backsplash and Countertop in MCB Break Room
